Increasing a nuclear plant's operating performance and efficiency

by Anthony Dippolito
Component Engineer
PECO Energy, Limerick Generating
Station, Pottstown, Pennsylvania

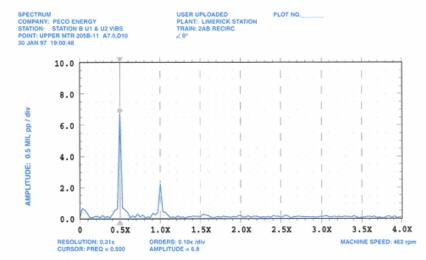
When the core flow increased, high vibration levels caused alarms which necessitated an increase in the Recirculation Pump speed (the Recirculation Pump had never previously been operated above 1520 rpm). Once Danger alarms were received, though, Operators immediately began reducing the pump speed until vibration levels dropped setpoints. the alarm Engineering was immediately contacted to review vibration data. Spectrum and full spectrum cascade data (Figures 1 and 2) indicate a 1/2X vibration component and a forward, circular precession of the vibration (negligible reverse vibration components). The orbit (Figure 3), though, clearly shows the classical characteristics of oil whirl: slightly less than 1/2X vibration frequency, circular shape, forward precession. (A review of the historical data from all the Recirculation Motors showed that oil whirl had previously occurred at approximately 445 rpm, during startup.) At 1520 rpm, vibration levels reached approximately 305 µm (12 mil) pp. Plant personnel decided not to exceed this speed, although this meant that less power would be produced until the next refueling outage in approximately 6 months.

Figure 1. Spectrum taken during recirculation pump startup showing apparent ½X malfunction frequency.

To eliminate oil whirl, the upper motor bearing design was changed to a tapered land bearing which was installed during the refueling outage. All signs of oil whirl were eliminated (Figure 4).

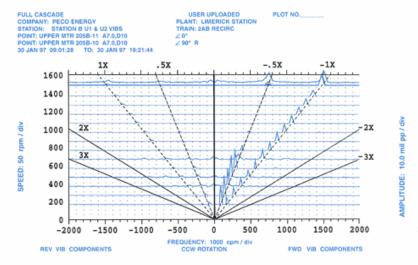
Figure 2. Full spectrum cascade of recirculation pump startup showing forward circular nature of malfunction (negligible reverse components).

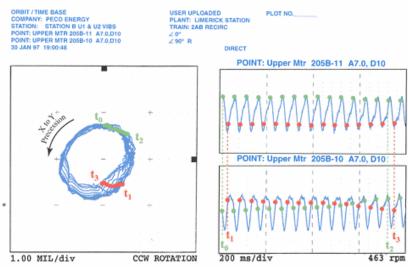
Figure 3. Orbit/timebase taken during recirculation pump startup showing circular, forward precession of malfunction. Slow change of Keyphasor® dot position, against direction of precession, indicates a frequency of slightly less than ½X.

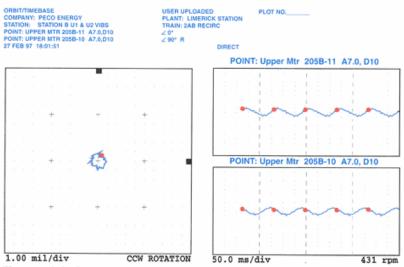
Figure 4. Orbit/Timebase taken during startup of recirculation pump after motor bearing was replaced.
